# Hoof Wall Resection and Reconstruction for a Tubular Defect

by Andrew Poynton FWCF

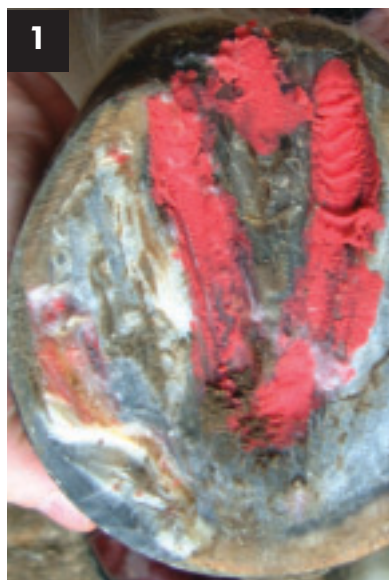
The white line in the region eventually deviated inward, forming a loop around the infection site (see photo 1). The farrier had suggested a few months previously that the horse might need veterinary care.

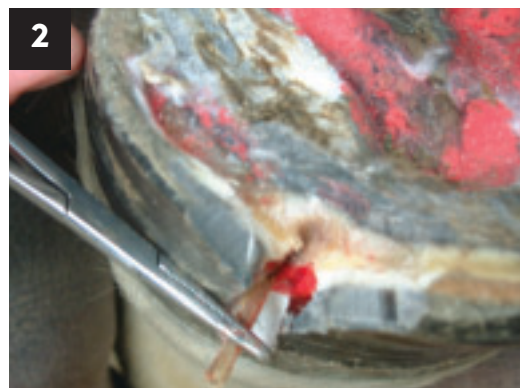
This revealed a fibrous tube that looked like a worm in the foot. It extended the full height of the wall (see photo 2). This

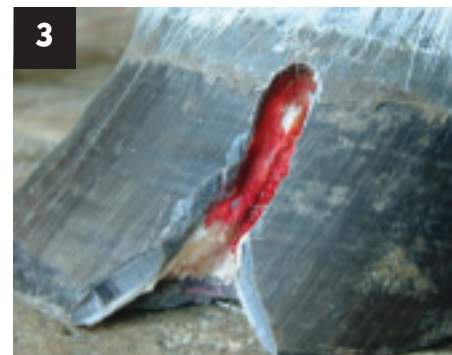
"worm" was removed skillfully by the veterinary surgeon without causing much bleeding (see photo 3). It was embedded within a groove formed in P-III but it was separate from the sensitive laminae.

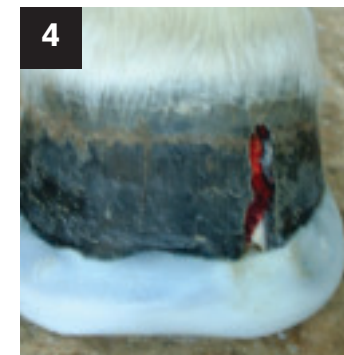
An Imprint thermoplastic shoe was fitted to the trimmed foot to stabilize the resected hoof. The void where the substance was removed was to be rebuilt when the underlying tissue had granulated (see photo 4 and 6), possibly in ten days to two weeks.

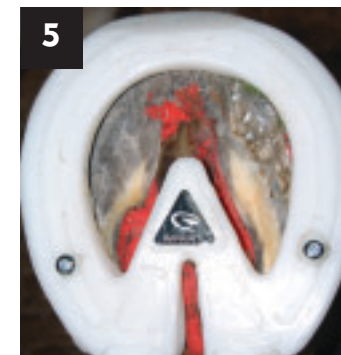
Two small, blunt-ended self-tapping screws were placed in the shoe prior to fitting to aid grip (traction) on smooth concrete (see photo 5).

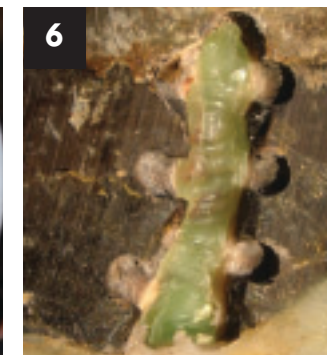
A number (three or four) of bulb shapes were routed out of the sides of the excavation, effecting a jigsaw keying interdigitation (see photo 6) to hold reconstruction material. This created a much larger surface area of bond as well as a mechanical attachment. It also resisted vertical shear forces.

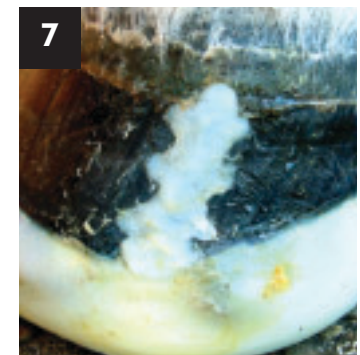
A thin layer of Imprint structural adhesive was applied. Then some softened Imprint thermoplastic granules were formed into the fault filling it completely, not overlapping the edges but slightly proud, (see photo 7) as when cooled there is slight shrinkage. The second stage of the procedure was complete.
